Contract #: 04-0120F4Cty: SF/ALA Rte: 80 PM: 13.2/13.9File #: 69.28**WELDING INSPECTION REPORT****Resident Engineer:** Siegenthaler, Peter**Address:** 333 Burma Road**City:** Oakland, CA 94607**Report No:** WIR-021500**Date Inspected:** 06-Mar-2011**Project Name:** SAS Superstructure**OSM Arrival Time:** 700**Prime Contractor:** American Bridge/Fluor Enterprises, a JV**OSM Departure Time:** 1900**Contractor:** Zhenhua Port Machinery Company, Ltd (ZPMC), Changxing Island **Location:** Shanghai, China

Orthotropic Box Girder (OBG) at Trial Assembly Areas

Segment 12AE (Side Panel T-Ribs at FL3 location)

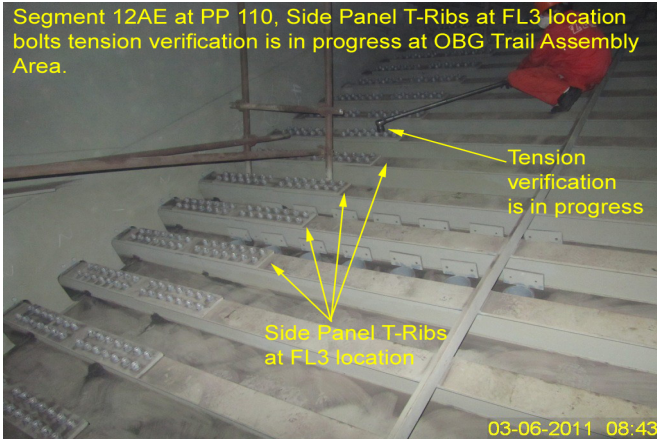
This QA Inspector witnessed the final bolt tension verification on bolts connecting the T-Rib to T-Rib at Side Panel Cross Beam side at Panel Points (PP) 110, PP 111 and PP 112 for Segment 12AE. The QA Inspector verified the bolt tension on a random basis and the results appeared to be in general compliance. The Inspection was performed against Notification No. 00620 dated March 06, 2011. The QA inspector observed reinforced splice plates are installed at following locations.

The bolt sizes used were M22 x 65 RC Lot # DHGM220114 and the final torque value established was 333 N-m.

The bolt sizes used were M22 x 80 RC Lot # DHGM220094 and the final torque value established was 470 N-m.
